Little Green

1400, 1425, 50Y6 Series

Leak

Machine is Leaking Out of the Bottom

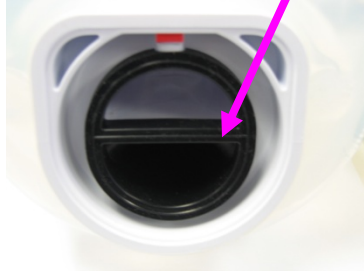
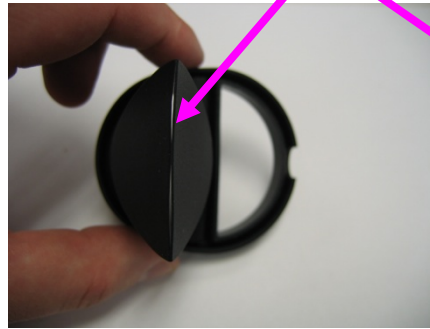
- **Make sure the black “duck bill” gasket** is not missing from the collection tank or inserted wrong (the tall “duck bill” side of the gasket should be inserted into the opening on the outer, rounded side of the tank). Ensure the gasket is open by taking it out and squeezing the tall “duck bill” flap, forcing it open on the end.

Gasket stuck closed

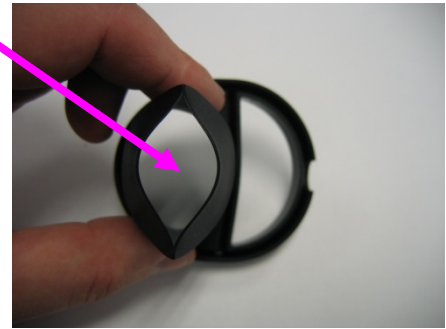
Squeeze sides to force open
